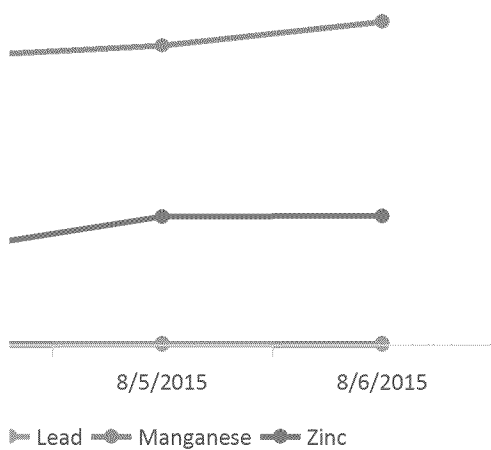
on: A68

Location ID	Date Sampled	Cadmium	Copper	Lead	Manganese	Zinc
A68	8/5/2015	0.828	3.45	0.232	737	199
A68	8/5/2015	0.815	3.16	0.283	727	238
A68	8/5/2015	0.974	3.52	0.82	757	324
A68	8/6/2015	0.85	3.26	0.329	817	326

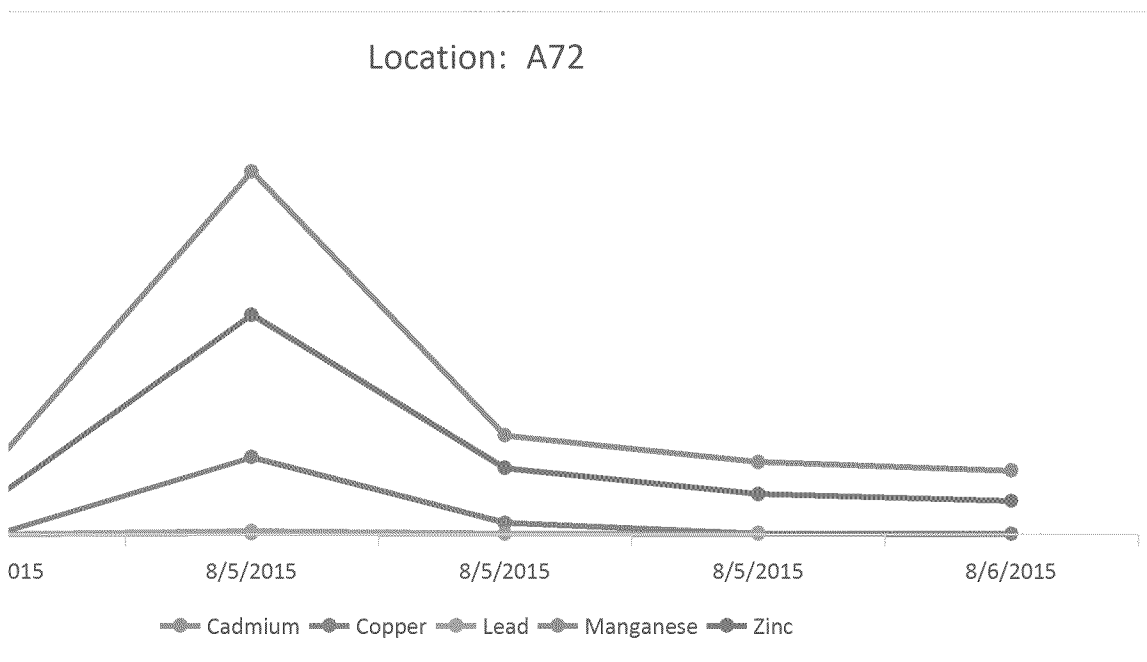
Location ID	De Sampled	Cadmium	Copper	Lead	Manganese	Zinc
A72	8/5/2015	1.81	9.27	0.225	1370	699
A72	8/5/2015	15.2	1410	50.7	6650	4020
A72	8/5/2015	4.29	205	3.12	1810	1210
A72	8/5/2015	2.59	11.4	0.118	1320	733
A72	8/6/2015	2.11	7.63		1160	609

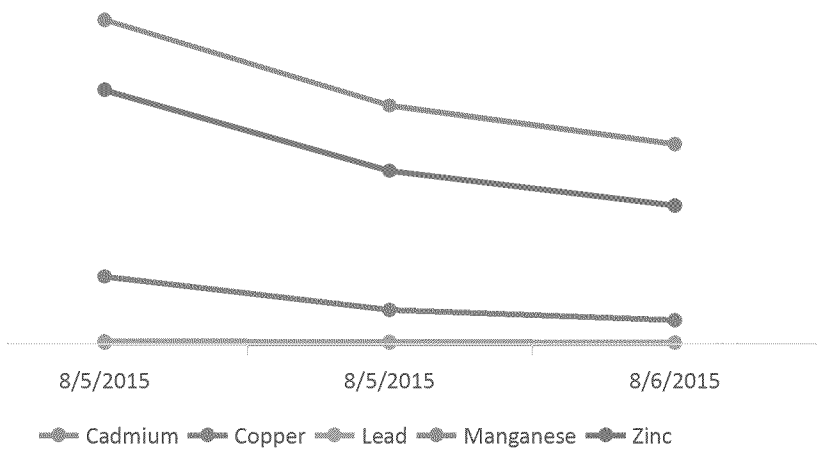
Location: CC48

ocation ID	Sampled	Cadmium	Copper	Lead	Manganese	Zinc
CC48	8/5/2015	30.6	2260	73.9	10900	8540
CC48	8/5/2015	19.1	1130	54.1	8020	5820
CC48	8/6/2015	14.2	786	30	6720	4650
